CLEMENTON LAKE DAM

NJ 00410

PHASE 1 INSPECTION REPORT NATIONAL DAM SAFETY PROGRAM

May, 1979

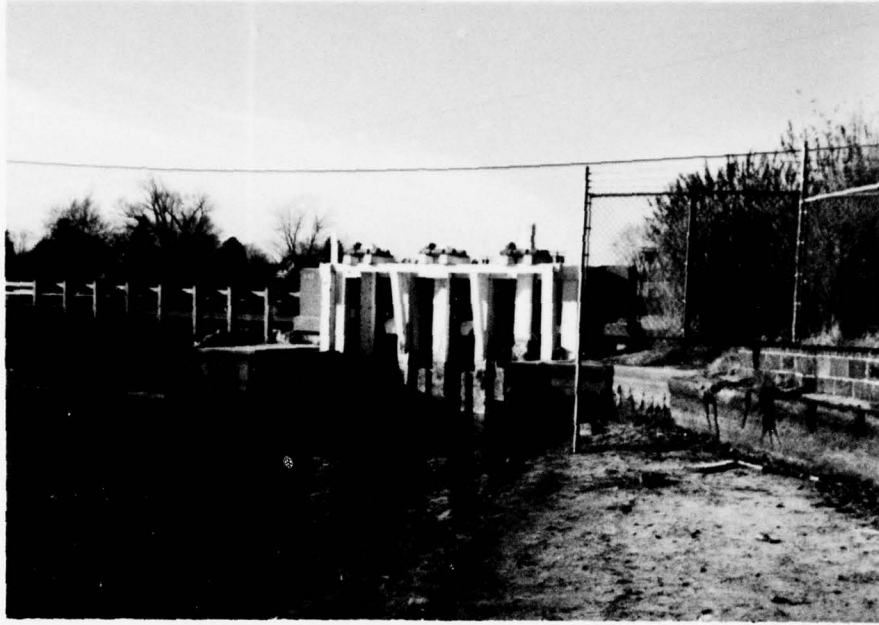
PHOTO 1

The spillway structure consists of 3 timber slide gates mounted in a timber frame, all of which were in good condition. Reportedly, all of the gates are operable. The lake was drawn down about 2.5 feet at the time of the inspection, exposing most of the height of the gates. The northeasterly gate was open to a height of about 1.5 feet and the invert was submerged by overflow.

UPSTREAM VIEW OF SPILLWAY

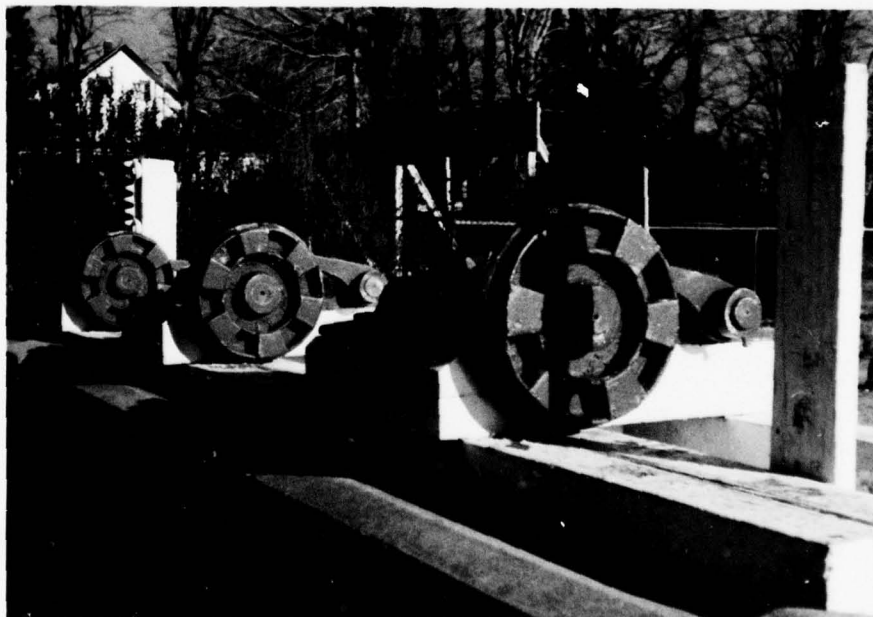
PHOTO 2

SPILLWAY GATE OPERATING MECHANISM

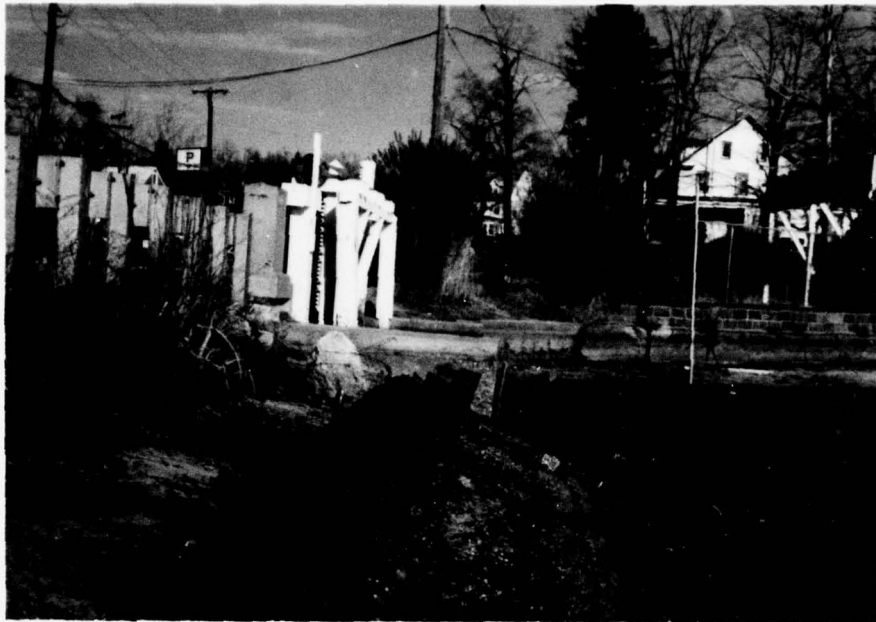
PHOTO 5

upstream slope of the embankment. The sheets had apparently rusted through at the normal water level. There was no evidence of riprap protection along the upstream slope as had been recommended in the 1974 dam inspection report and the slope was still in need of stabilization. Longitudinal cracks were noted in the bituminous roadway pavement on the upstream edge of the dam crest. Areas were observed where pavement had been undermined and broken away at the upstream edge. This damage was apparently due to poor road drainage and perhaps wave action.

Reportedly, the steel sheet piles along the upstream dam slope were installed about 15 years ago as slope protection to prevent erosion caused by power boat wakes. This sheeting has been neglected and allowed to deteriorate due to the absence of power boat traffic on the lake in the recent past.

UPSTREAM FACE OF EMBANKMENT
DETERIORATED STEEL SHEET PILING

(2) Repair eroded areas and the broken and cracked roadway pavement on the upstream slope of the dam. Riprap should be placed along this slope to protect it against wave attack and drainage induced erosion.

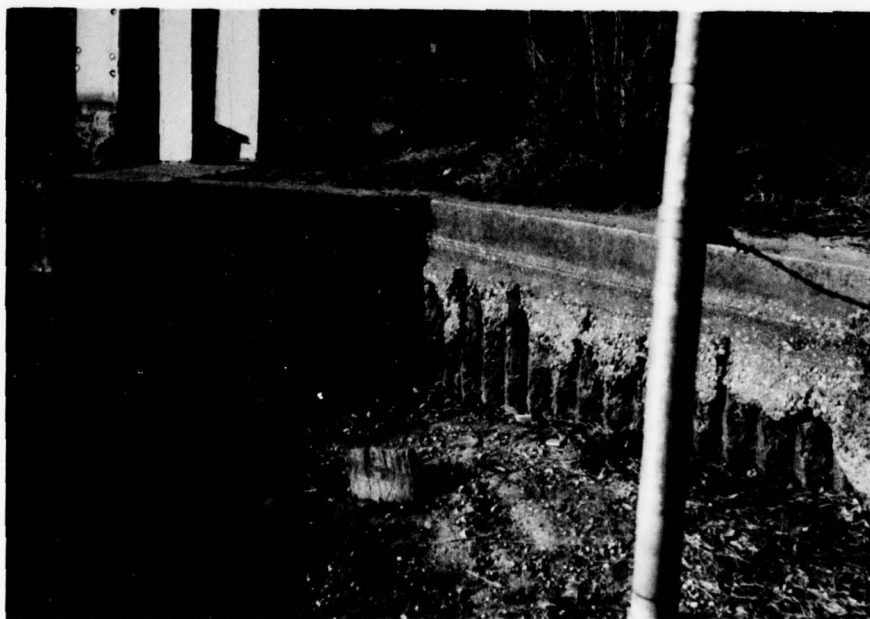
PHOTO 6

DETERIORATED STEEL SHEET PILING AND
CONCRETE ADJACENT TO SPILLWAY

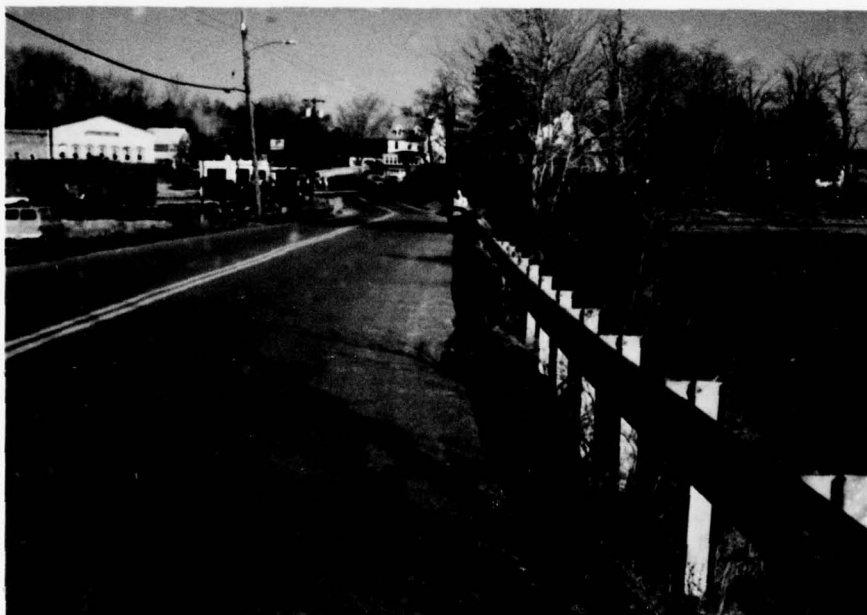
PHOTO 8

PAVED ROAD ON CREST OF DAM

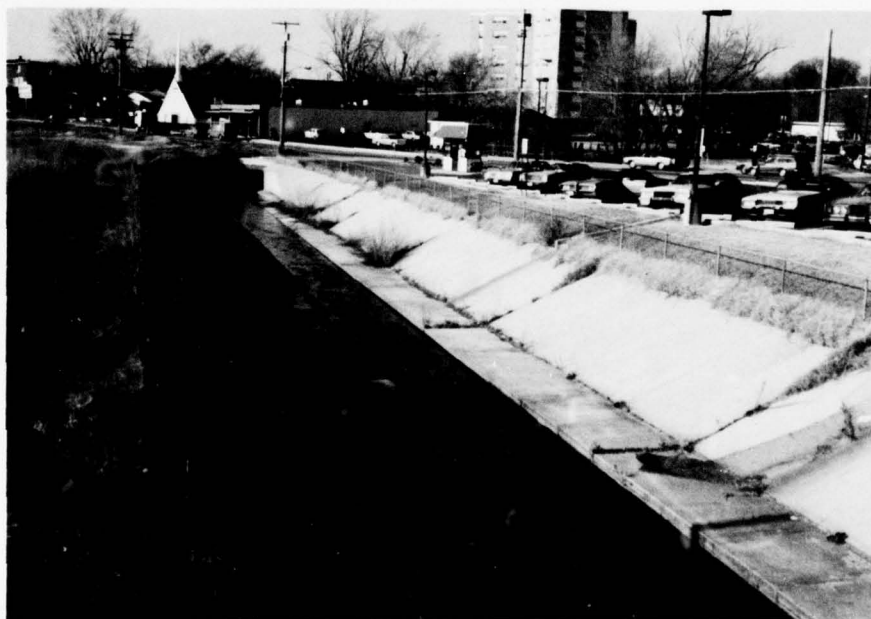
PHOTO 10

Discharge from Clementon Lake enters a trapezoidal concrete channel that extends about 300 feet to two downstream road bridges, beyond which the channel remains in a natural condition. The downstream channel is known as the North Branch of Big Timber Creek which flows through a densely populated portion of the Borough of Clementon.

DOWNSTREAM CHANNEL
